Report on SNS RFQ Status

Jim Steimel

SNS Operational RFQ

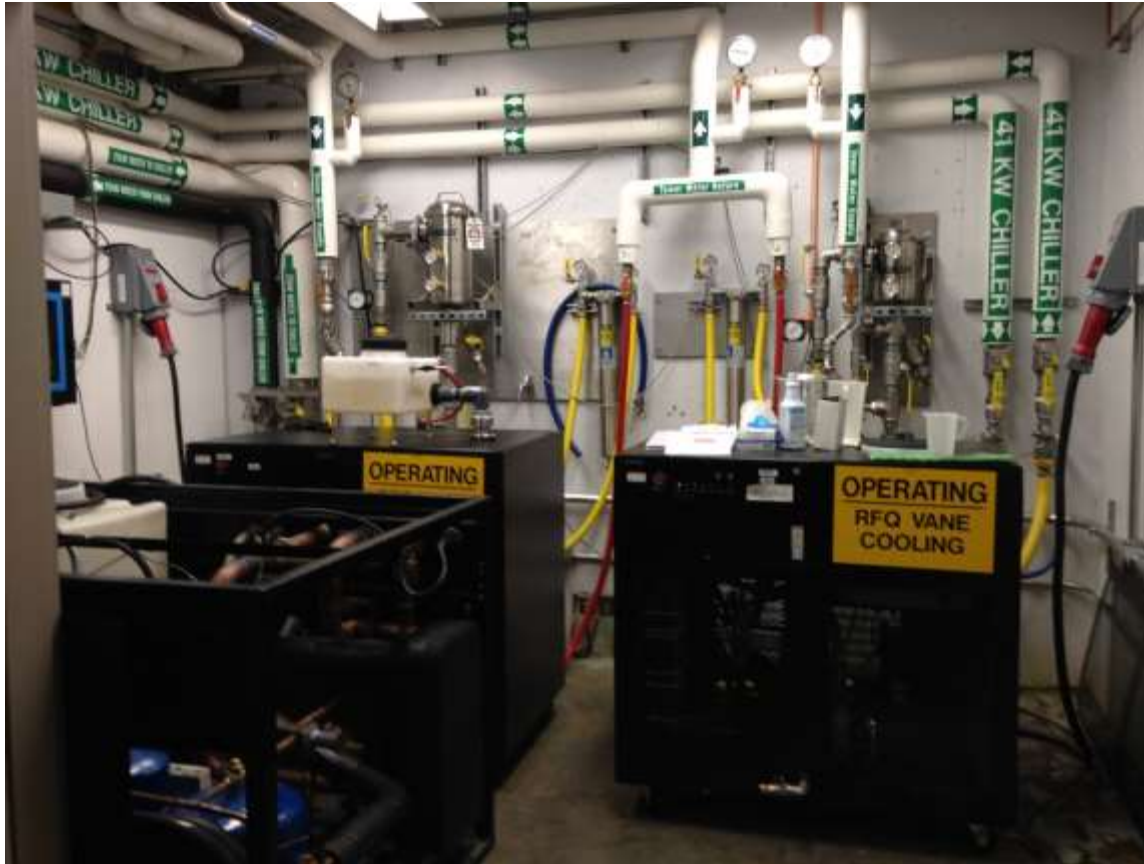
RFQ Chiller System

- Cooling of RFQ done with closed loop Glycol systems.
- Body and vane loops are independently controlled.
- Temperature stability is 0.1°C and response time is 1-2 minutes.
- A spare unit is kept close for quick exchange.
